Manhole Inspection Summary

Manhole # S37A__011MH

Insp Date: **8/25/08 12:30 PM**

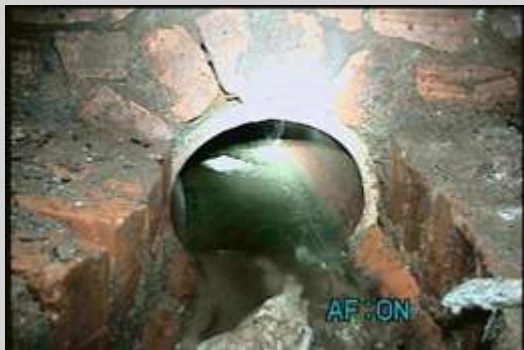
12 O'Clock Outflow

8 in. Circular Gravity Sewer
Pipe Out @ 12 O'Clock

Invert Depth: **9.63** (ft.) Flow Characteristics: **Fast**

Infiltration: **None** Pipe Seal Cond: **Unknown**

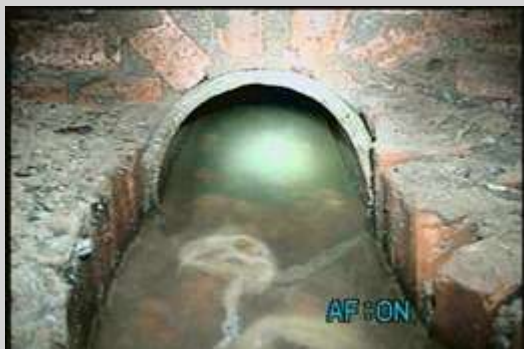
9 O'Clock Inflow

8 in. Circular Gravity Sewer
Pipe In @ 9 O'Clock

Invert Depth: **9.33** (ft.) Flow Characteristics: **Slow**

Deposits: ☐ None ☐ Mud ☐ Sludge ☒ **Debris** ☐ Grease
